GRANDE RONDE BASIN FISH HABITAT

ENHANCEMENT PROJECT:

2000 ANNUAL REPORT

Project No. 8402500

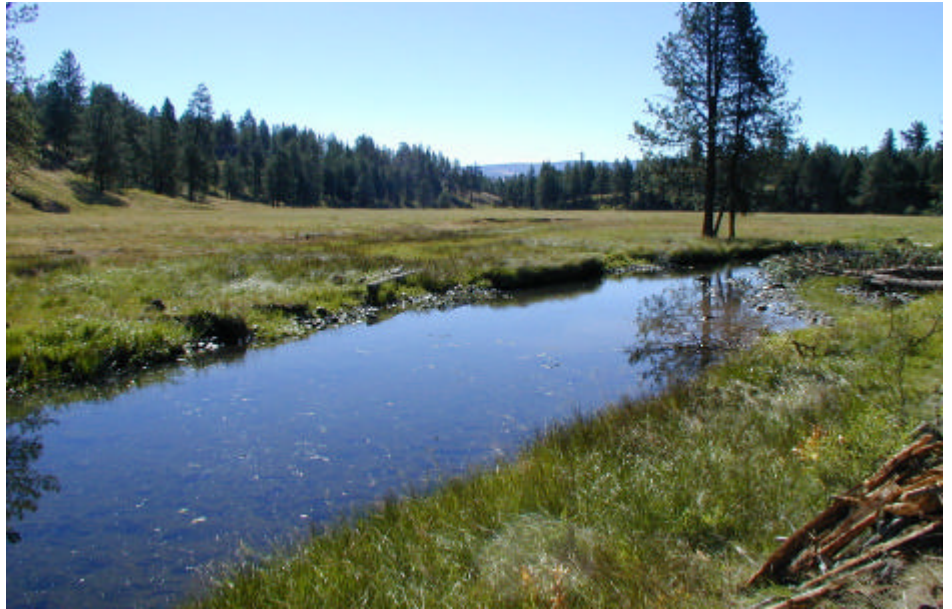
Figure 5. Meadow Creek, Habberstad property, instream work Site 1, 7-25-2000. An Engineered Log Jam (ELJ) was installed to create complex pool habitat and encourage reestablishment of the former meander.

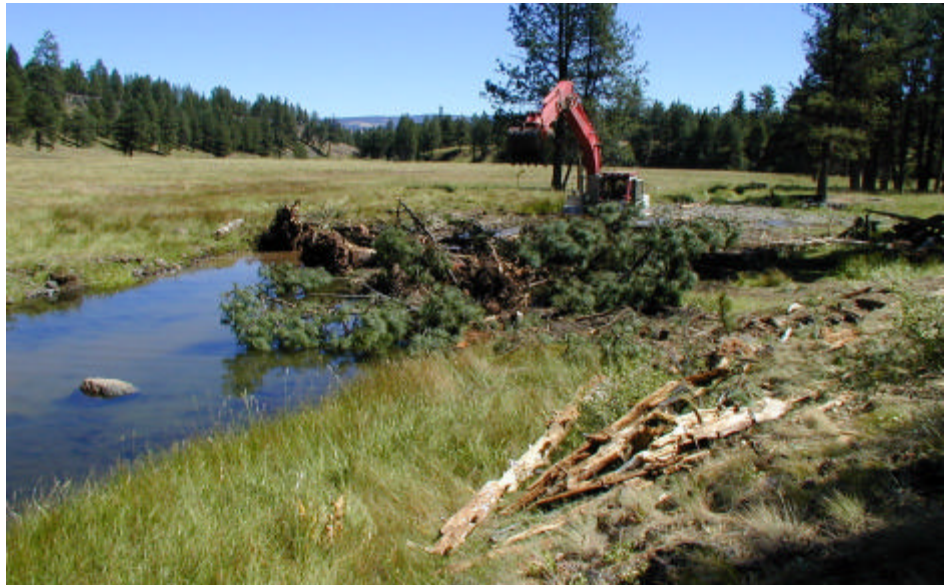
Figure 6. Meadow Creek, detail of the completed structure from the left bank looking downstream, 7-25-2000. Large rootwads facing upstream will encourage scour during high flows and maintain the depth of the excavated pools. Cross members have been cabled together to maintain integrity of the structure and will recruit additional small floating wood. Deposition will occur on the downstream (background) side, and eventually the channel thalweg will move to the left and recharge the old meander.

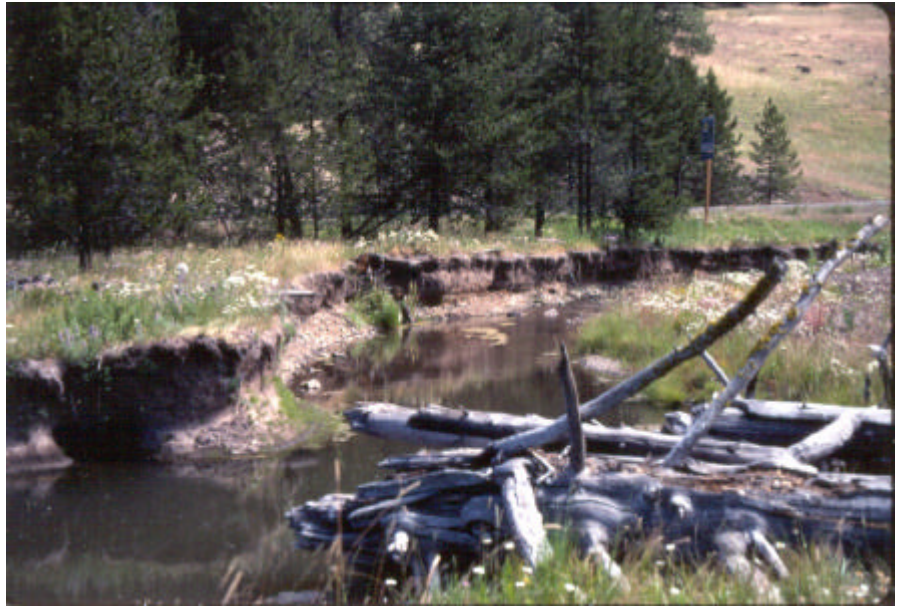
Figure 7. A vertical (6 ft.) eroding streambank on Camas Creek, 8-6-2000. This area was providing poor habitat and producing sediment downstream; if left unattended it would eventually damage Highway 244 in the background.

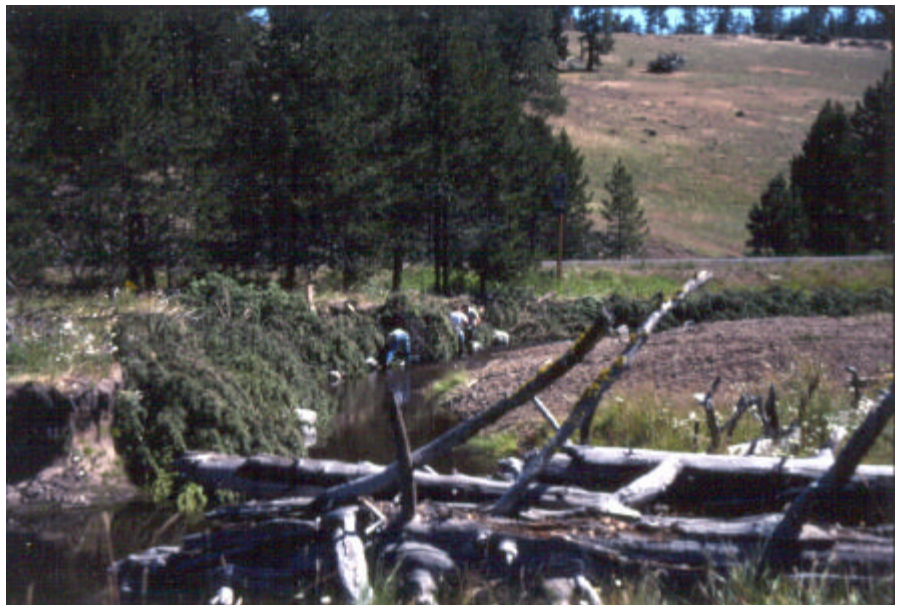
Figure 8. Installation of lodgepole “riprap” at the same site, 8-8-2000. This soft approach will provide both habitat enhancement as well as bank stability, and is a better alternative than rock riprap which would likely have been installed if erosion continued. ODFW personnel cabled or wired trees and toe boulders together for stability during flooding. In the short term the whole trees and boulders provide valuable instream cover for salmonids. Over the years the “riprap” will collect fine sediments and establish seedbeds, allowing new vegetation or planted willow cuttings to become established. The landowner donated all of the trees for this work.

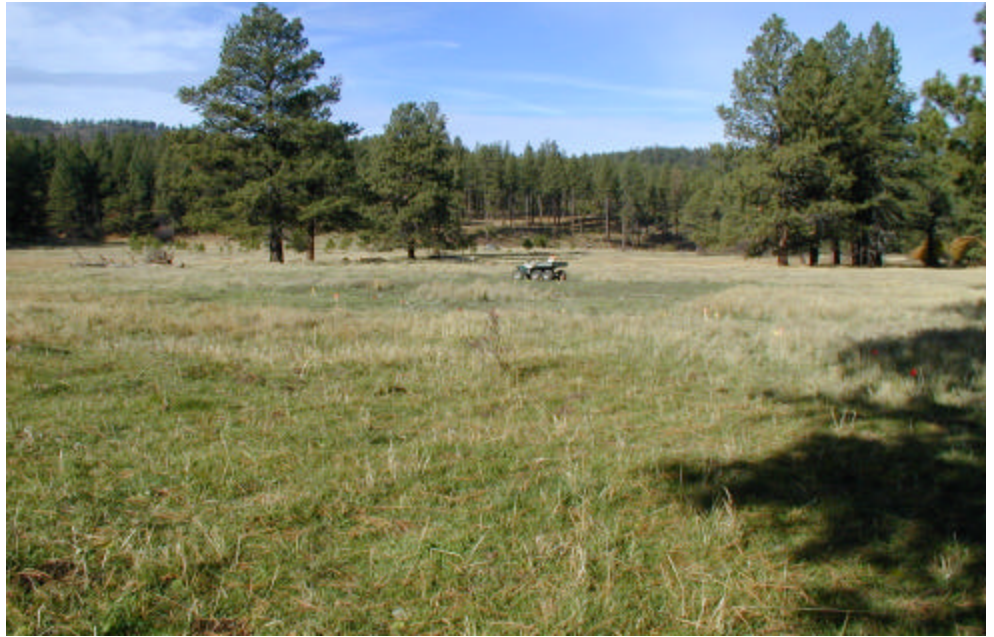
Figure 9. Milk Creek/Hall Ranch project area, October, 16, 2000. This pre-project photo is taken from the upstream end looking northwest. The existing stream channel (not visible) is to the right of the photo and runs in a ditch next to Highway 203. In addition to inadequate fish passage due to an undersized culvert, the current stream channel is artificially steepened, has no meanders and very little pool habitat. Stakes and flags indicate locations of pools and riffles of the new channel. Channel design was based on a Reference Reach section immediately upstream of the project.

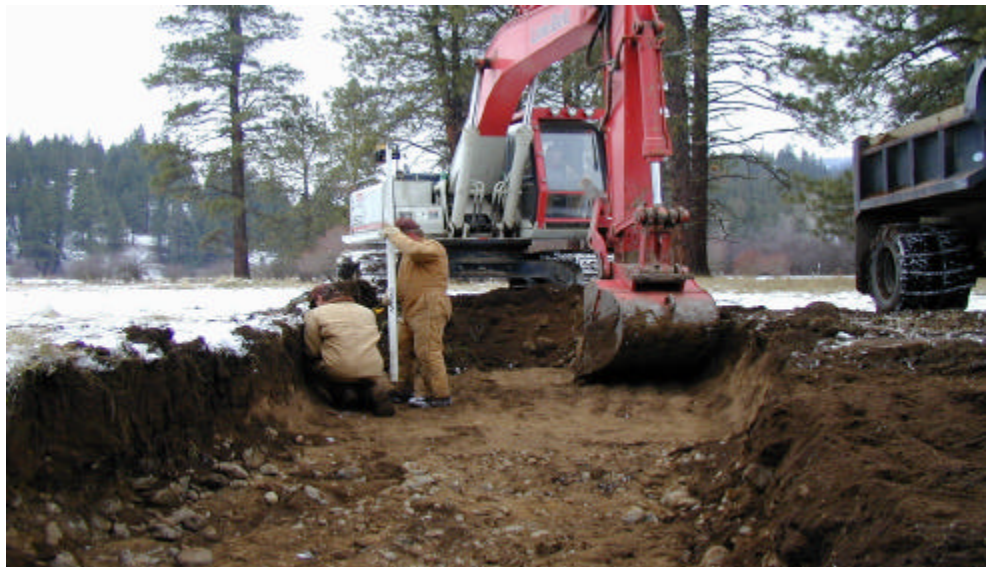
Figure 10. Milk Creek, November 14, 2000. ODFW crews survey in thalweg and bankfull indicators near Pool #7 during construction. Ken Coe of Mitrac Construction excavates the initial rough cut and loads spoils into an ODFW dump truck. During the excavation cobbles and gravels are separated from silt/loams and placed into riffle sections where needed. These will act as natural grade control areas and help prevent channel degradation (downcutting).

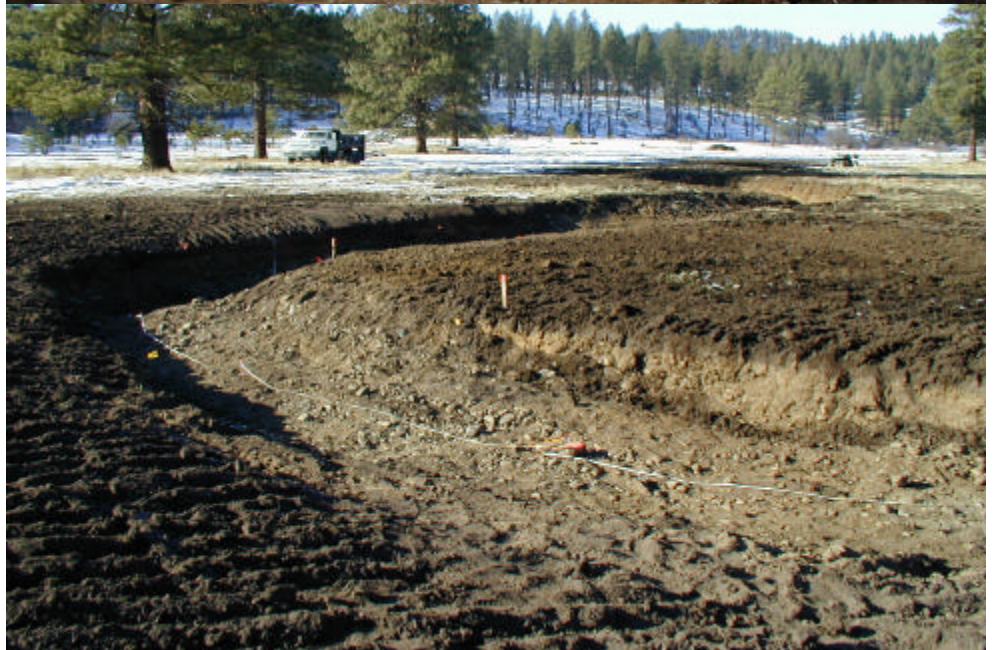
Figure 11. Milk Creek, November 15, 2000. Final shaping is completed and resurveying of the new channel in progress. The photo is taken at Pool #4 looking downstream. Points bars have been sloped back at about a 10:1 ratio and are ready to receive sedge/rush transplants from excavated wetland soils. An artesian well was plumbed in that supplied 12 gpm to begin wetting the channel and help establish riparian plants prior to the first winter floods that will occur in 2001-01.

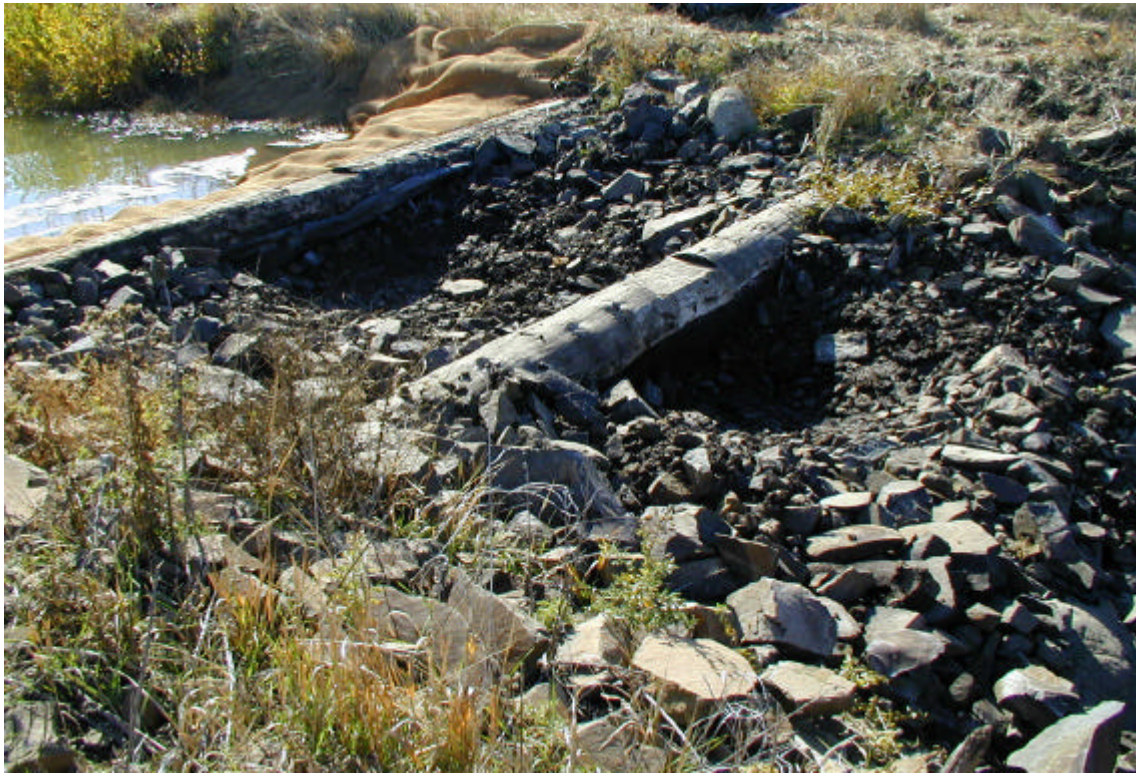
Figure 12. Bear Creek/Cunha Ranches, October 18, 2000. Jump pools were excavated behind log weirs to improve fish jumping ability. Coir fabric or geotextile cloth was trenched into the upstream faces of the structures to improve sealing/trapping of water.

3. Adding deeper layers of coir fabric or geotextile cloth on the upstream faces of the weirs to seal them better (Figure 5). Originally only a 6-ft. deep layer of cloth was installed that was inadequate to prevent subsurface flow from occurring from June to December. In some cases bentonite was distributed on upstream faces of the weirs to speed up the sealing process.

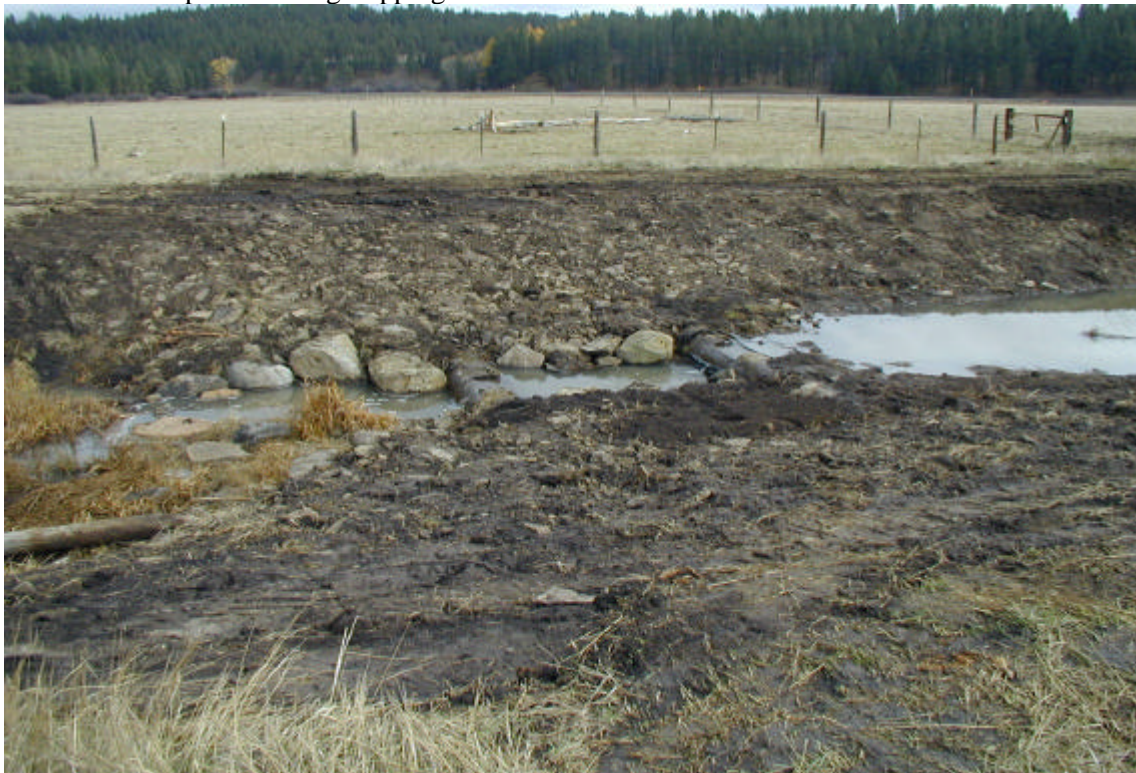
Figure 13. Bear Creek/Cunha Ranches, October 20, 2000. A completed set of weirs that has sealed up and is now running water over the tops. Banks have been sloped which will allow riparian vegetation to become established. However, this work is only a temporary fix, and in 2001 and beyond additional work will include reestablishment of a natural stream channel with constructed meanders, pools and riffles.

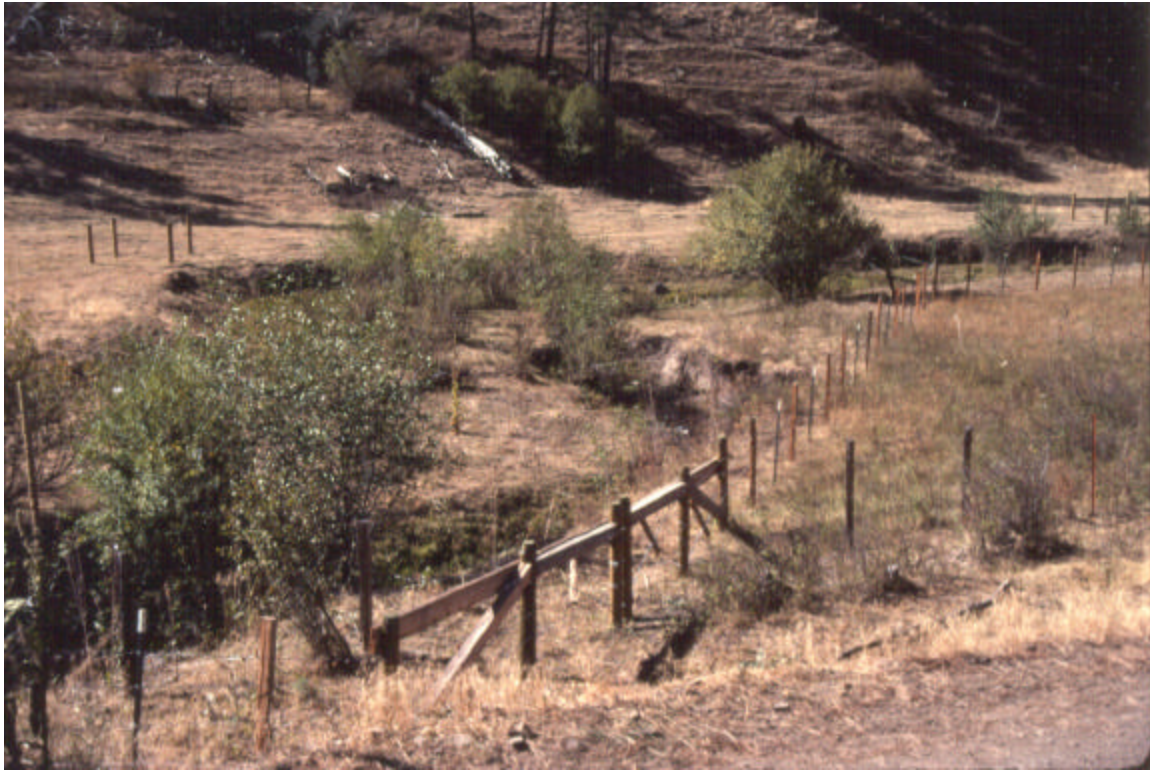
Butte Creek, McDaniel property, Photopoint #5, September 25, 1991. Vertical cut banks and only moderate amounts of riparian vegetation are evident. The newly constructed fence on the right bank appears to have been placed too close to the streambank.

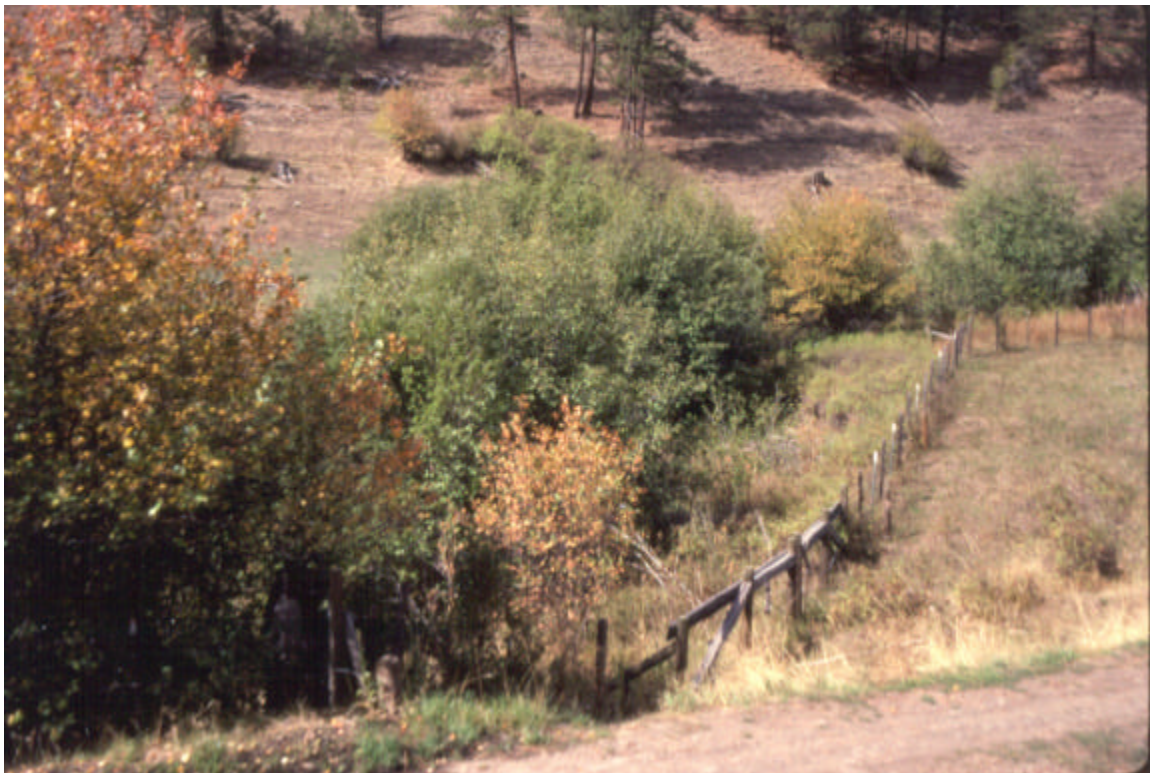
Butte Creek, McDaniel property, Photopoint #5, September 7, 2000. A dense canopy of alder, willow and hawthorns is now shading the stream channel which is no longer visible. Erosion on the right bank has halted even though the stream experienced severe flooding in 1997 and 1998.

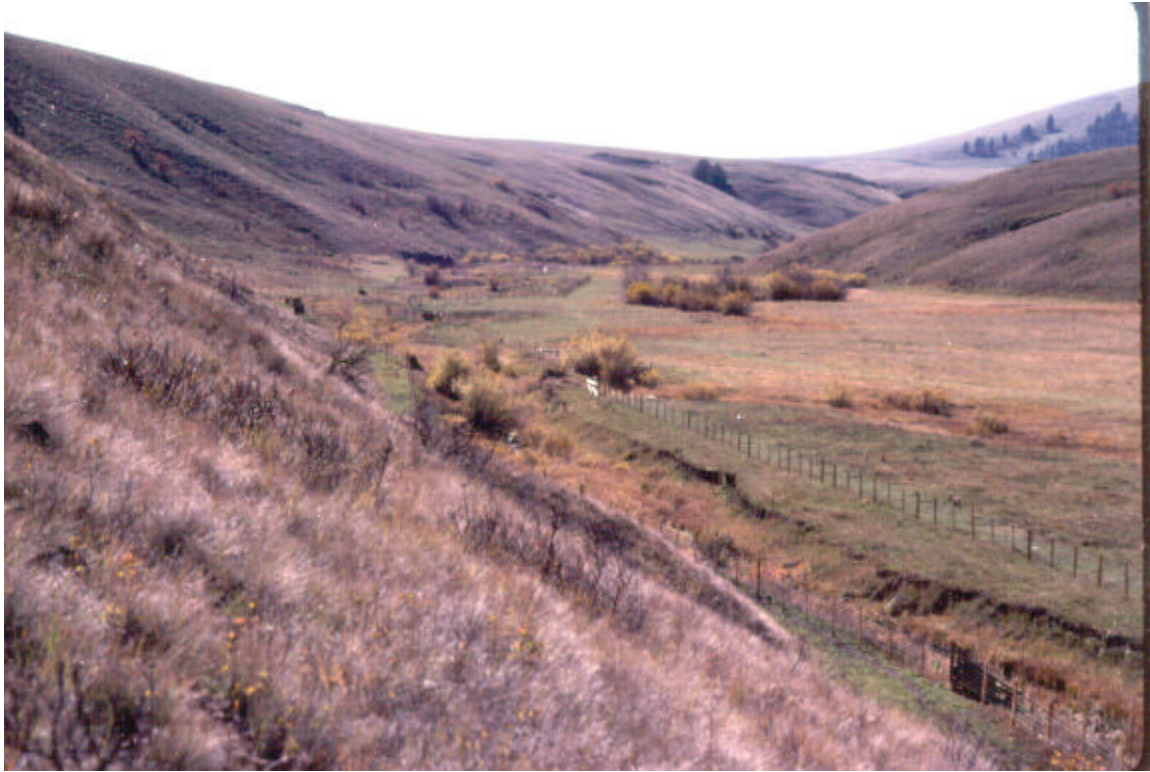
Salmon Creek, McClaran property, Photopoint 4a, October 10, 1989. In years past the stream channel had been pushed against the hillslope, and the channel had downcut several feet. Old stream meander scars are evident in the center, right side of the photo.

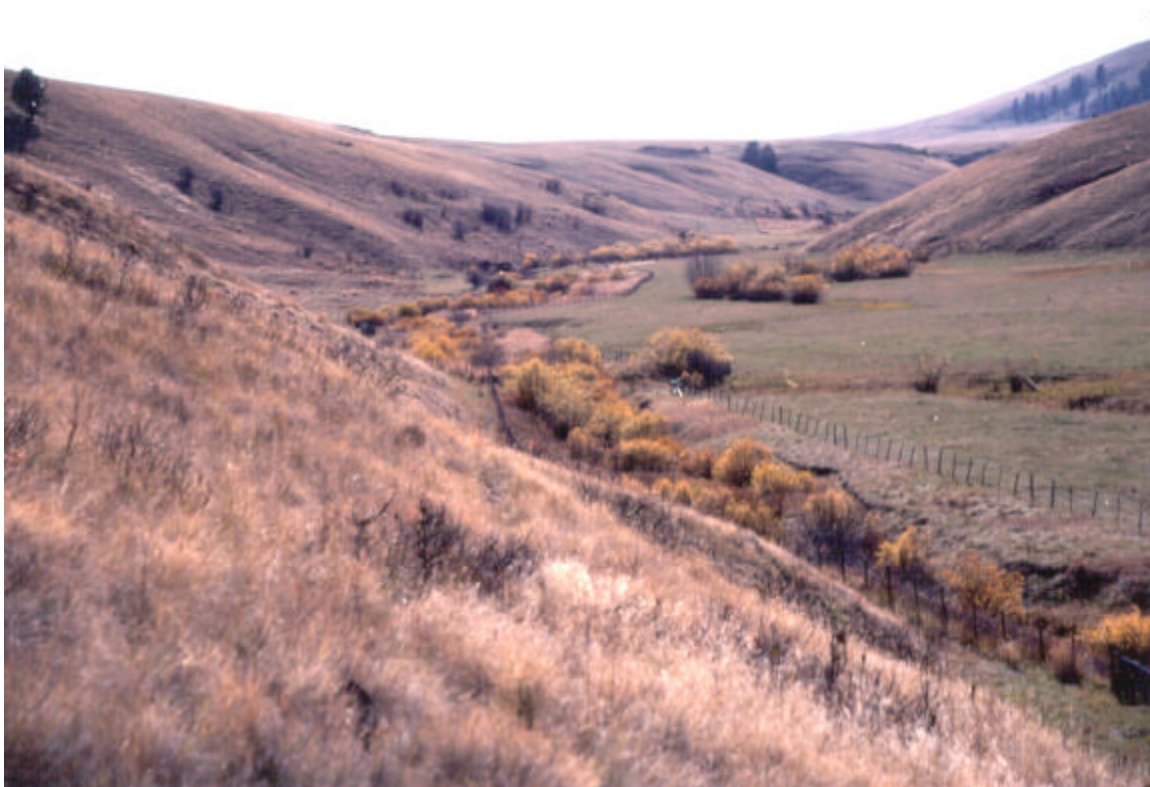
Salmon Creek, McClaran property, Photopoint 4a, October 17, 2000. A canopy of willows has developed, and the stream has evolved from a Rosgen G→F→C stream type within the entrenched area. Stream temperatures are 3-4 degrees Celsius cooler at this site compared to a monitoring station 2.3 miles upstream.

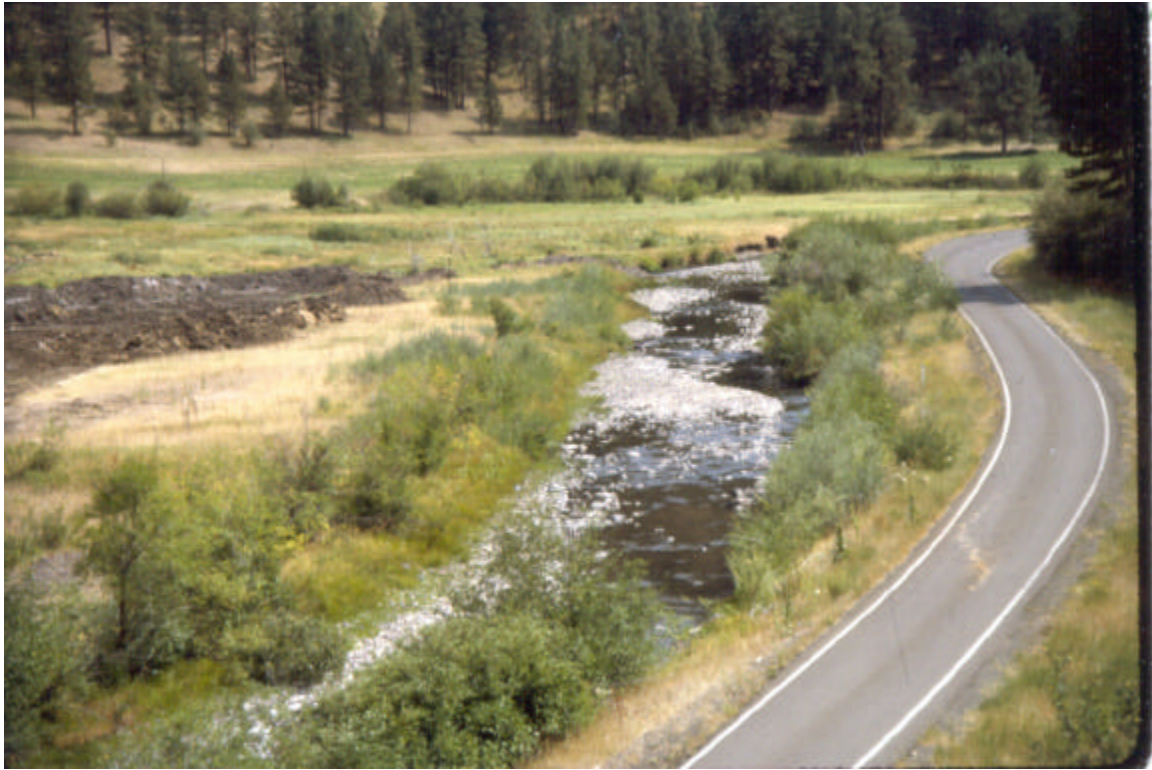
Chesnimnus Creek, Yost property, Photopoint #5, August 7, 1987. A wide, shallow stream channel with bare gravel bars are evident in this pre-project photograph. The bare soil on the left is a pond constructed by the landowner.

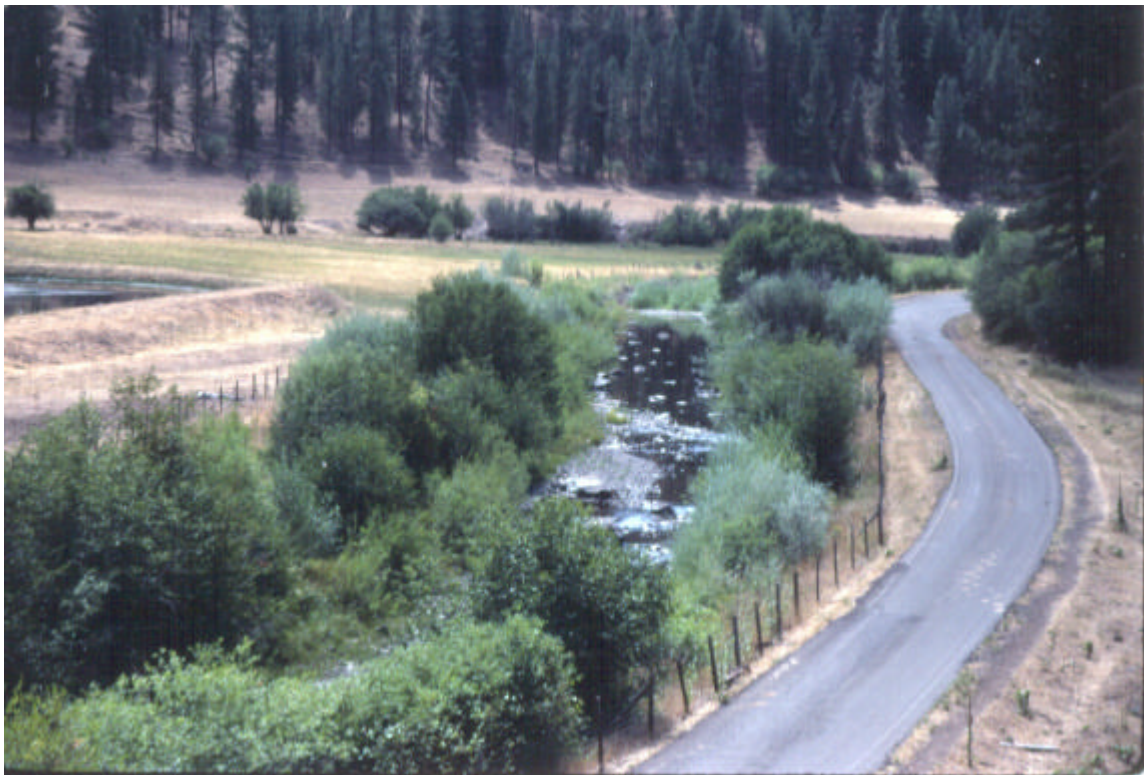
Chesnimnus Creek, Yost property, Photopoint #5, August 10, 2000. Despite the fact that beavers have constructed dams several times in this area, the riparian vegetation has flourished. The channel has narrowed and deepened, and is more shaded.

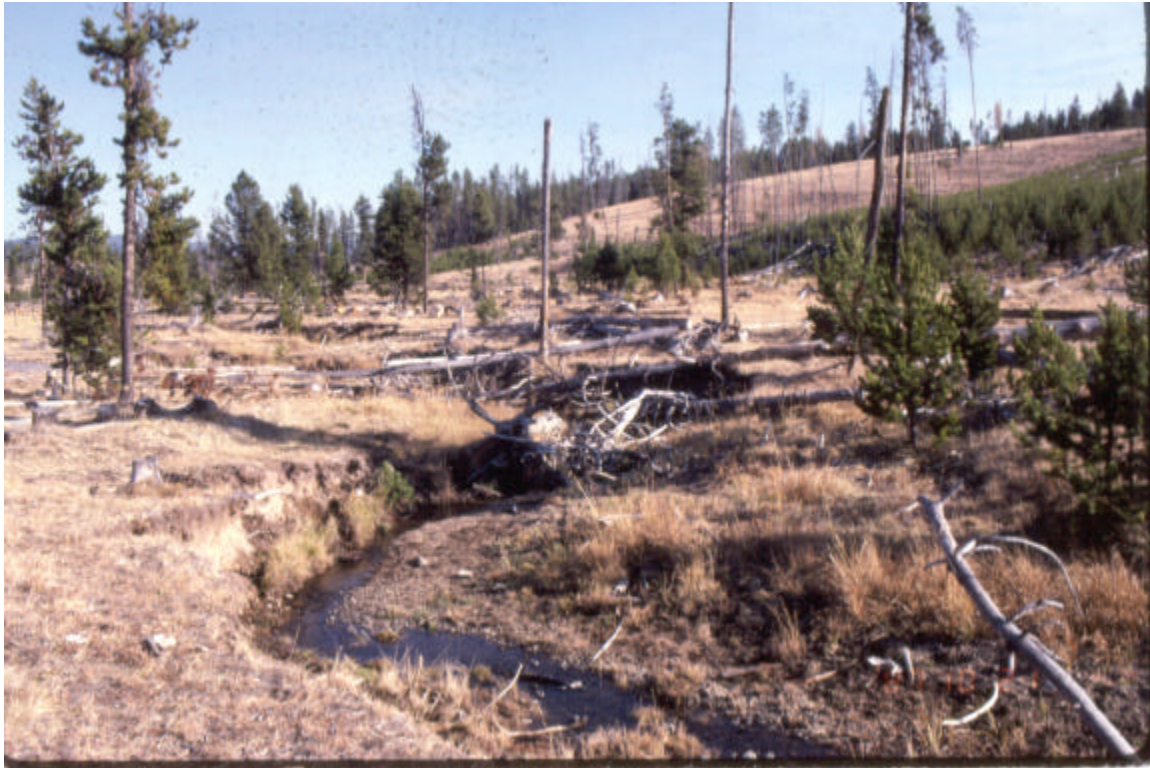
Fly Creek, Smith property, Photopoint 7, October 21, 1987. The pre-project photograph shows a stream suffering from intense grazing pressure and timber harvest.

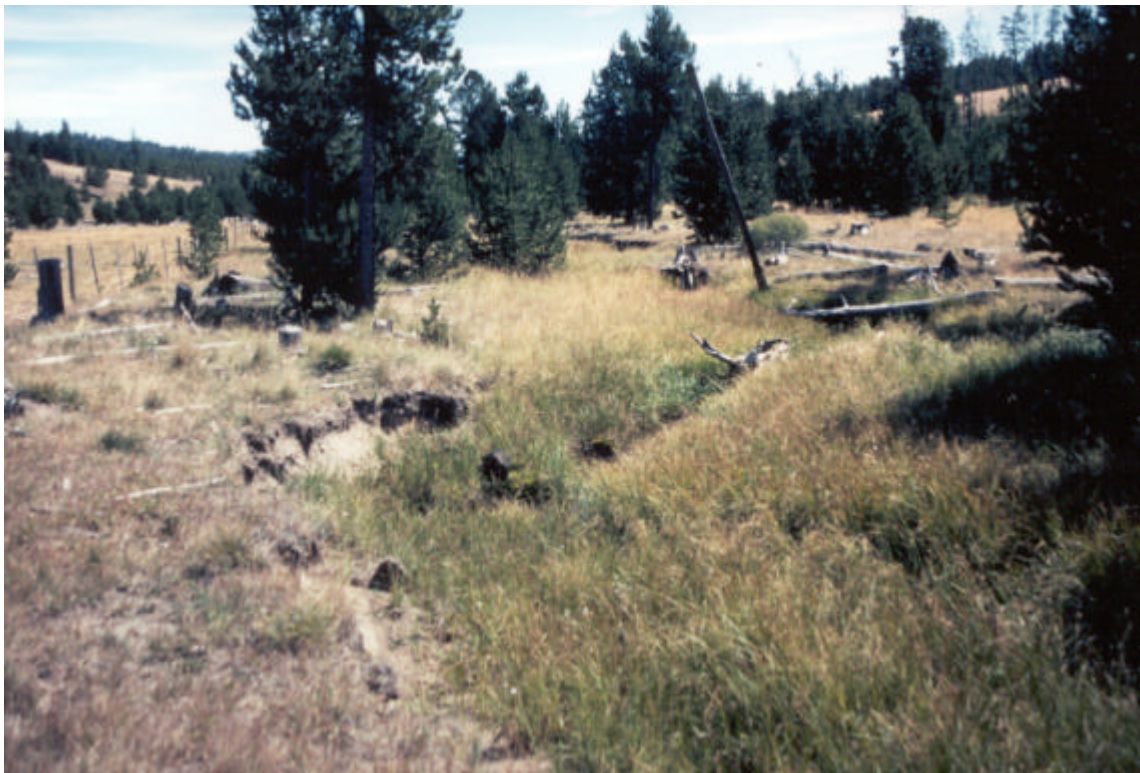
Fly Creek, Smith property, Photopoint 7, August 22, 2000. After 13 years of recovery young lodgepole pine are recolonizing the site. The stream channel (no longer visible) has evolved into a low width/depth ratio Rosgen E type stream due to the establishment of a thriving sedge community.

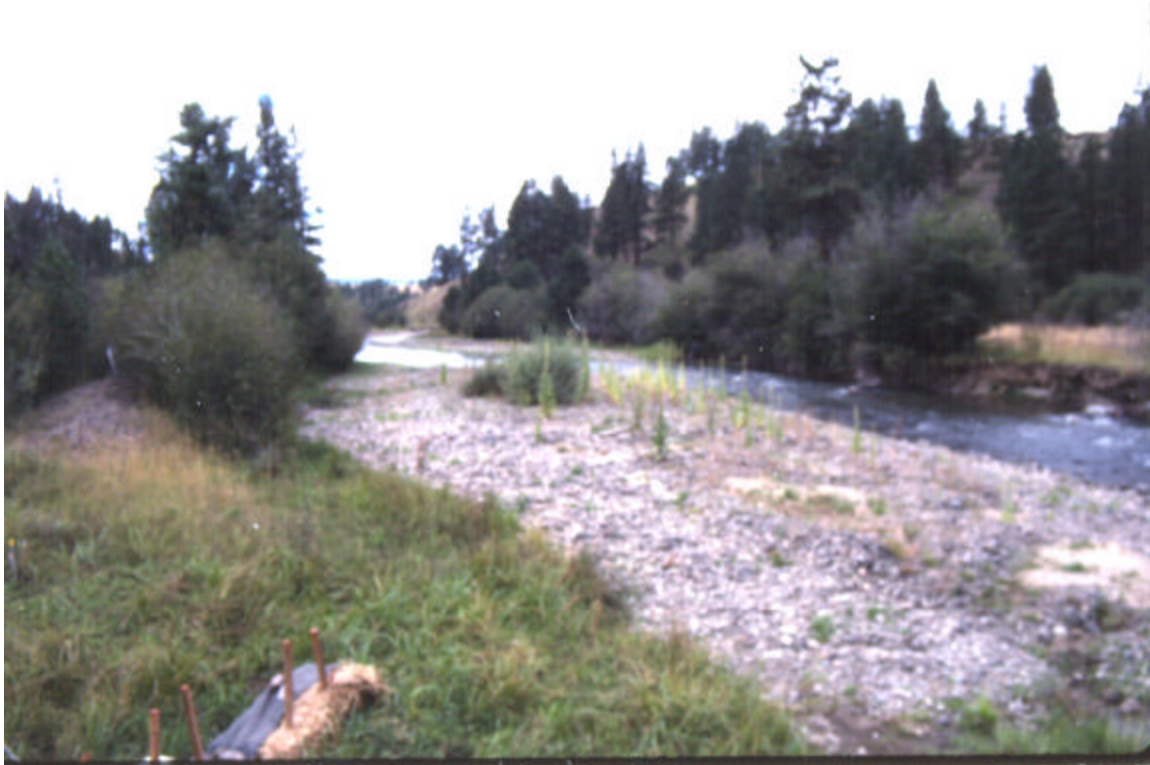
Upper Grande Ronde River, Delve property, Photopoint 1a, August 24, 1993. High bedload movements occurred during the flooding of May 1991, and this reach has been artificially constricted by the landowner and from highway construction in the areas upstream and downstream of the photo. Note erosion control matting in lower left of the photograph.

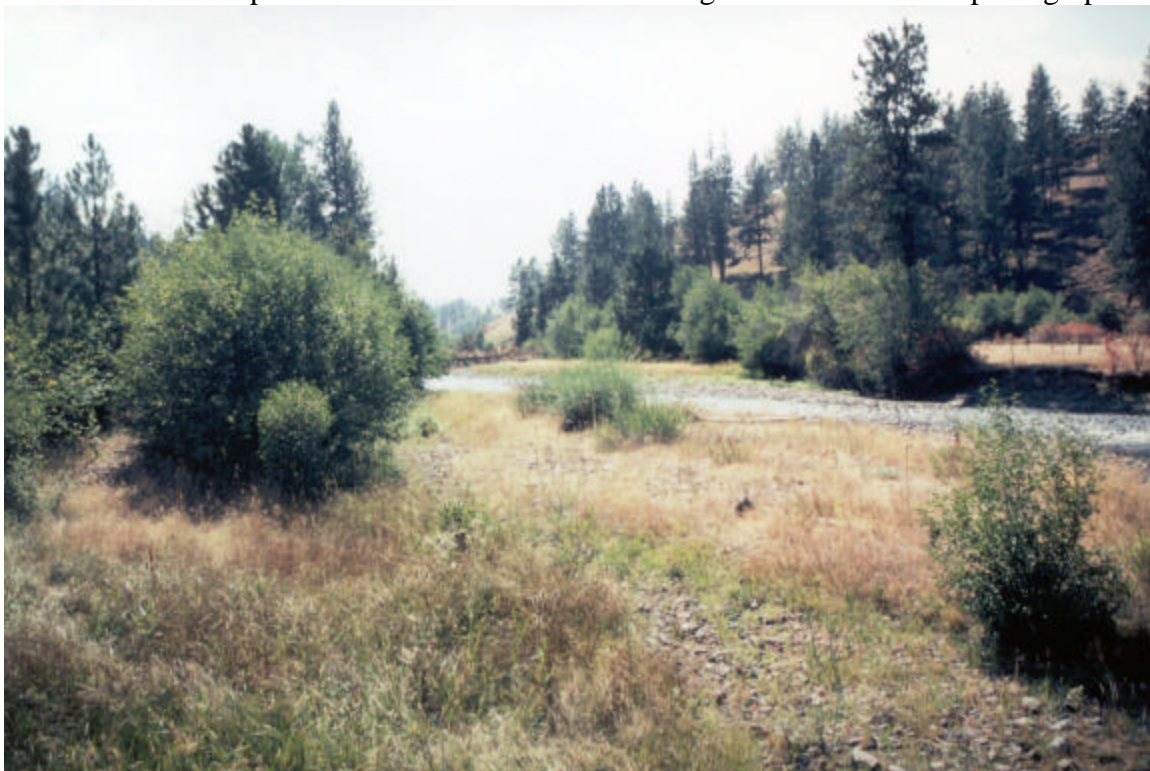
Upper Grande Ronde River, Delve property, Photopoint 1a, September 6, 2000. Recovery has been slow, but the channel is beginning to reshape itself as deposition has occurred on the point bar, and young sedges and alders become established. The opposite bank is still cutting, but this is necessary in order for the stream to restore itself into the correct pattern.

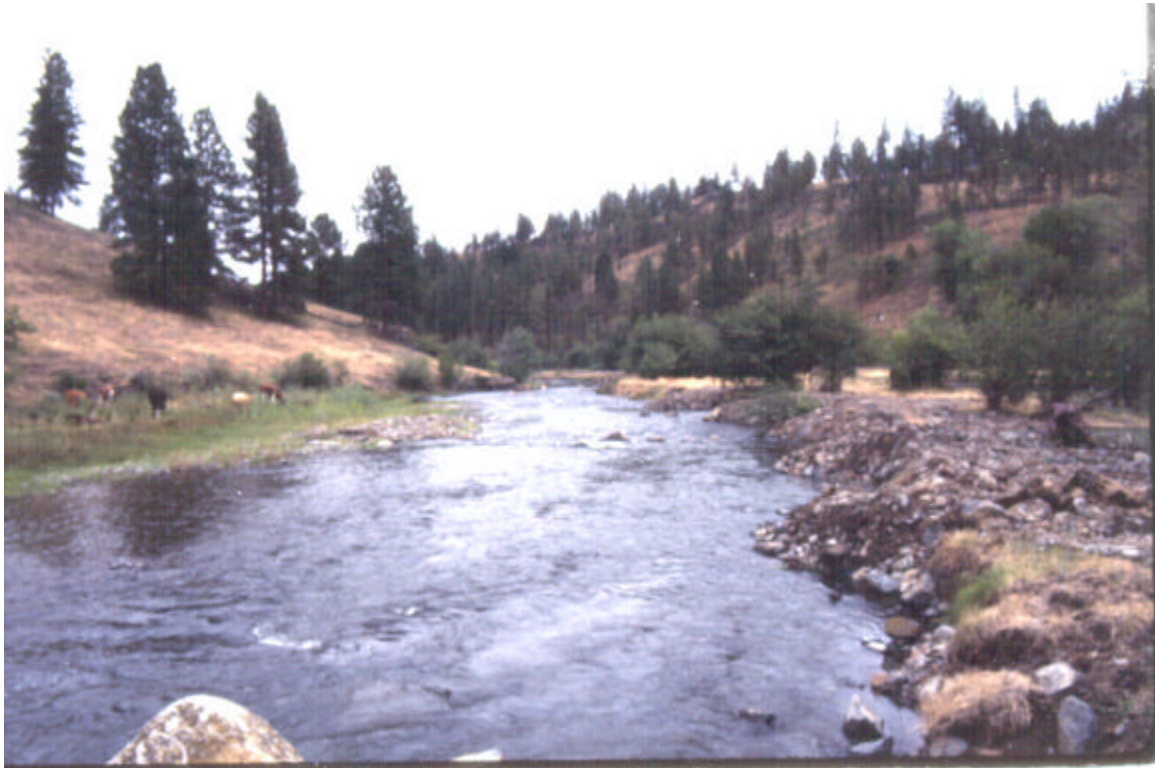
Upper Grande Ronde River, Bowman/Hoeft property, Photopoint 6, August 20, 1990. Prior to fencing a series of rock jetties were placed on the right bank to prevent further erosion. A wide, shallow stream channel is evident, and very little streamside vegetation is present.

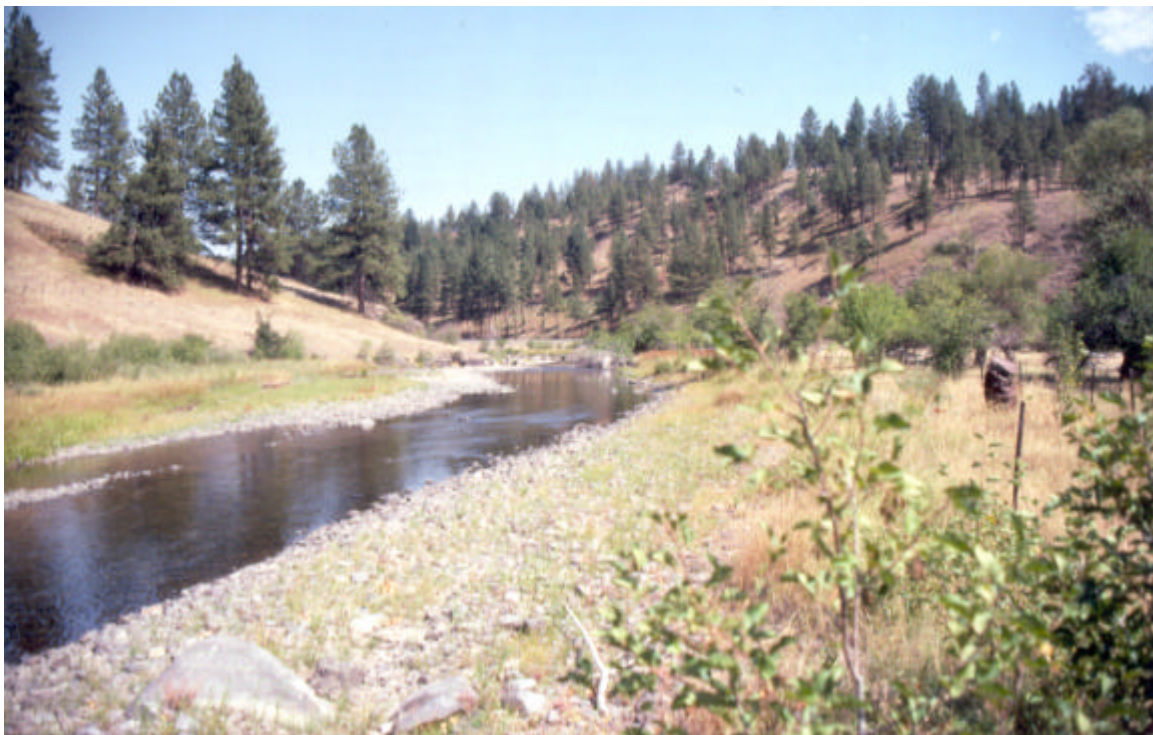
Upper Grande Ronde River, Bowman/Hoeft property, Photopoint 6, August 17, 1990. Although the jetties are no longer the preferred method of bank stabilization, they quickly trapped sediments during the flooding of 1991 (note deposition below the protruding boulder on the right bank), and the channel has narrowed. Recovery is slow in this reach, but some young alders are becoming established.
